PIXEL DETECTOR REINFORCED SECTIONS

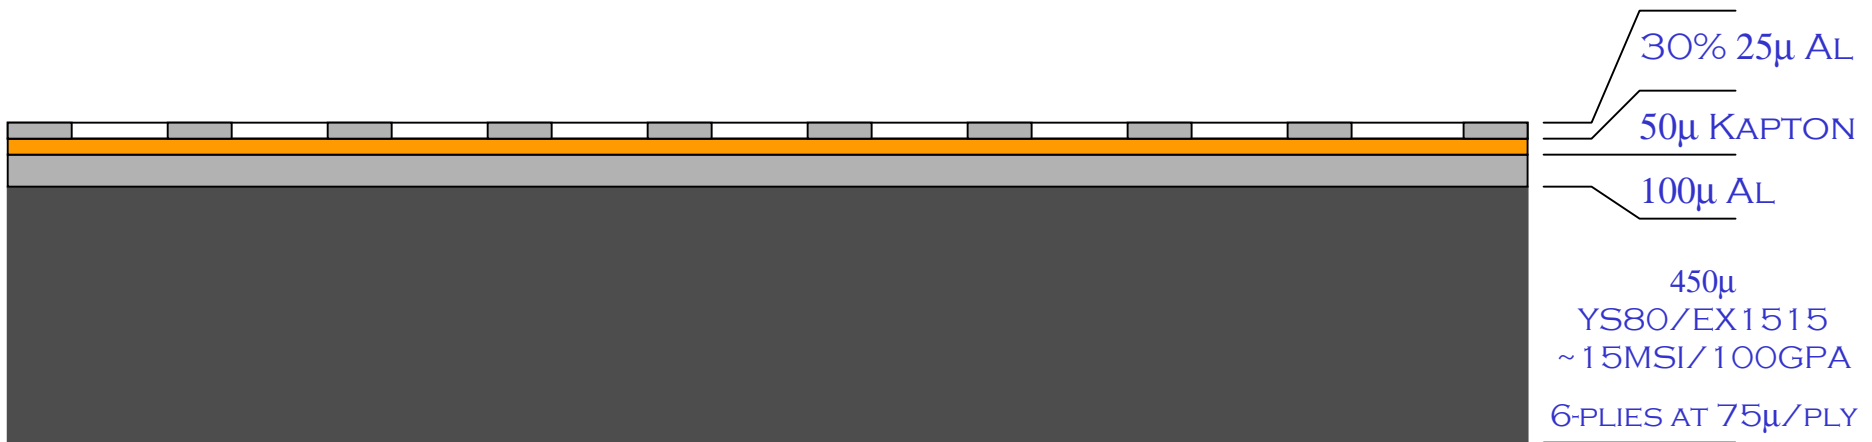
NOMINAL SHELL LAMINATE

$$\%X_0 = 0.045/24 + 0.01/8.3 + 0.005/24 + 0.3(0.025/24) = 0.36\%X_0$$

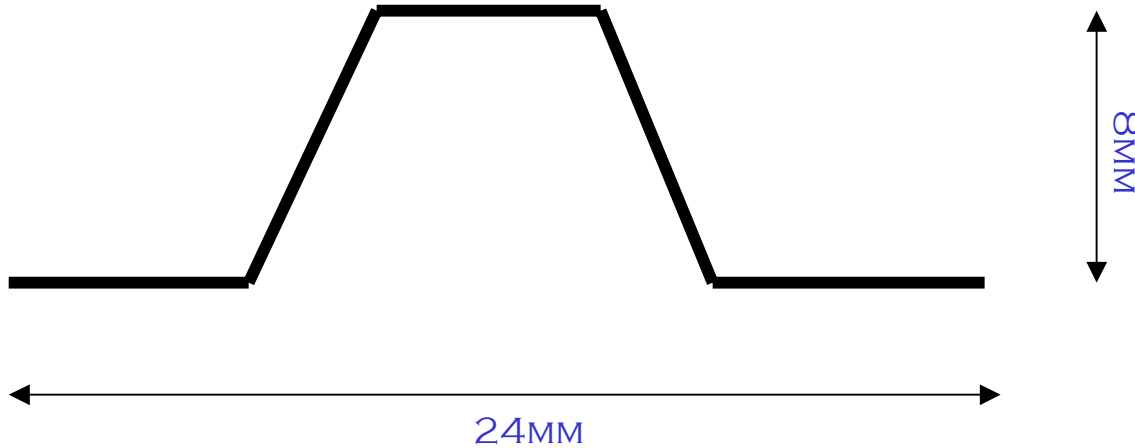
TOP HAT LAMINATE

MATERIAL EQUIVELANT—40MM BY 0.450MM CFRP

#STIFFENERS/SECTION IS 6, REINFORCED TOP, BOTTOM AND SIDES

24-STIFFENERS X 40MM/STIFFENER = 960MM

TOTAL CIRCUMFERENCE OF SHELL IS $2\pi \cdot 230 = 1445\text{MM}$

SIX STIFFENERS PER QUARTER ADDS 60% ON AVERAGE—MAY NEED TO REDUCE

LOOK INTO INTEGRATING THE SUPPORT WITH LATERAL STIFFENING RIBS

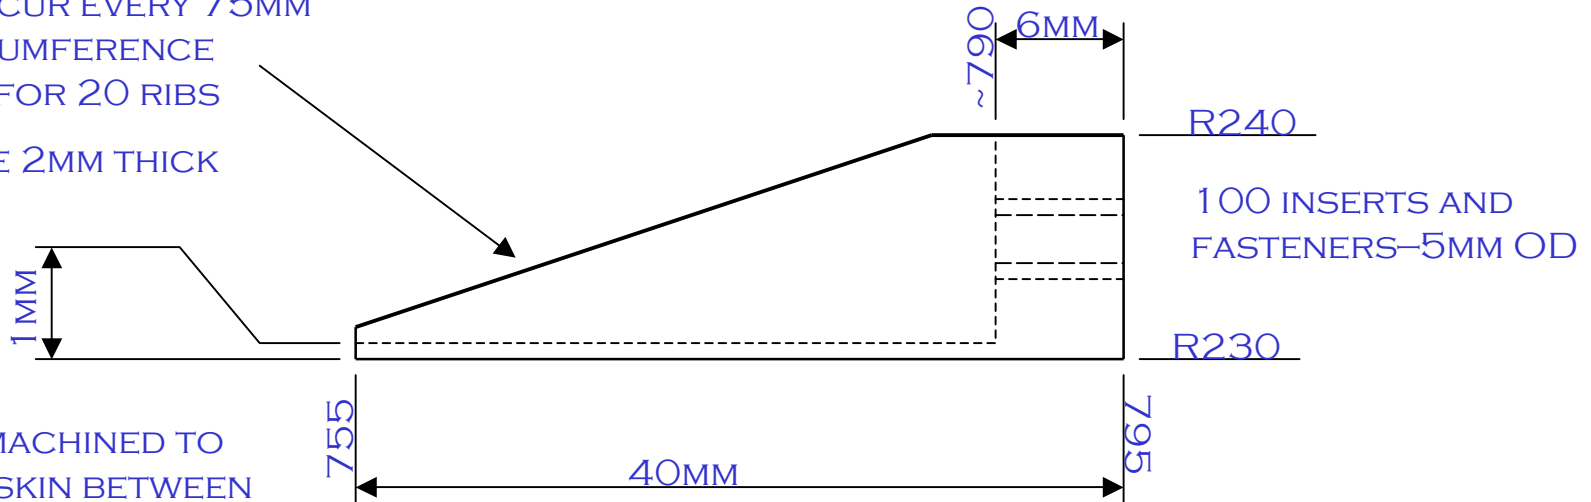
PIXEL DETECTOR END FLANGES

RIBS OCCUR EVERY 75MM
ON CIRCUMFERENCE
MAKING FOR 20 RIBS

RIBS ARE 2MM THICK

FLANGE IS MACHINED TO
1 MM THICK SKIN BETWEEN
RIBS—RIBS ARE TAPERED TO
HELP MATCH STIFFNESS

WITH INSERTS AND FASTENERS INSTALLED, END OF
FLANGE (6X10 ANNULUS) IS $\sim 10\%$ METAL

SHOULD INVESTIGATE TITANIUM—ALUMINUM IS NOT
STIFF ENOUGH, AND STEEL IS TOO HEAVY

INSERTS MAY HAVE TO BE STEEL
